SPACEPORT ONE: CONSTRUCTION ENVIRONMENTAL REPORT

Client	CnES
Project/Proposal No;	P58
Version	V1
Date	28 February 2025

Project Name:	Spaceport One: Enabling Construction Programme
Document Title:	Construction Environmental Manager Report to Planning
Client Name:	CnES
Author:	Gareth Gentles
Reviewed:	
Approved:	
Date:	28 February 2025
Version:	V1
Project / Proposal Number:	P58

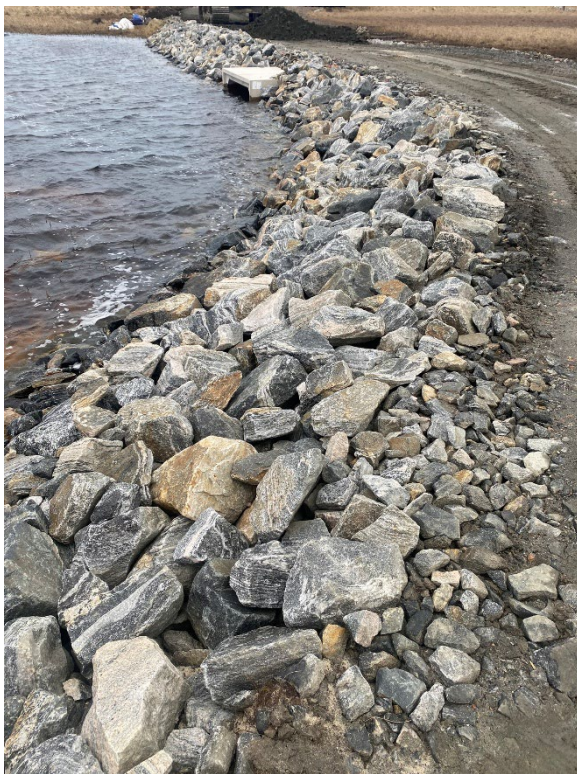
- 2.1.1.1 The temporary dam has been removed from both the upper and lower sections of Loch Scolpaig (Photo 1). Water has been reintroduced in a controlled manner to allow for settlement before the complete dam structure is removed from the loch bed. Laboratory tests for suspended solids and pH have been conducted and demonstrate no measurable impact on the water quality of the loch. Further information and sample results are available in Section 2.5 Water Quality.

Photo 1 Temporary dam removed

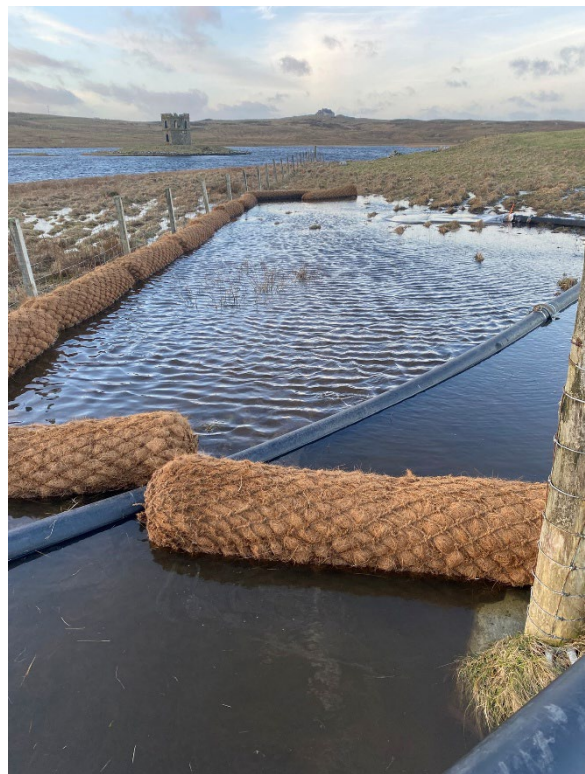
- 2.1.1.2 The pumping system and desilters have been removed from the site. Settlement ponds and silt control measures remain in place to prevent any overland water flows during adverse weather conditions from impacting water quality (Photo 2). It is anticipated that these control systems will remain until the areas have naturally re-vegetated (Photo 3). This will be reassessed in March once the vegetation growing season has commenced and the risk of any impact to water quality is reduced to an acceptable level.

Photo 2 Settlement pond

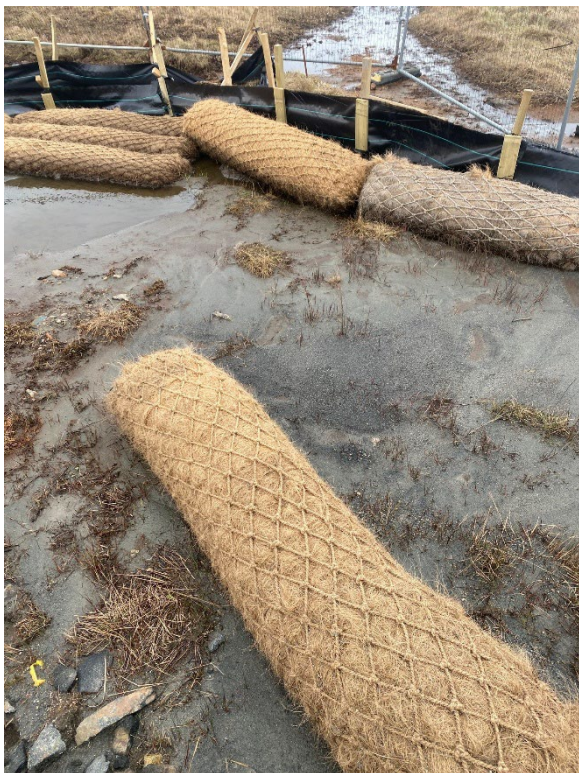
Photo 3 Silt settlement areas, potential for re-vegetation

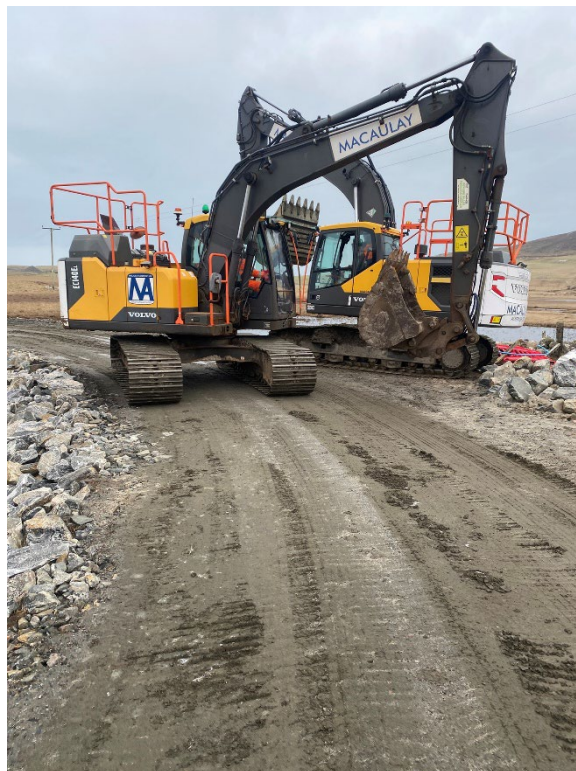
- 2.1.1.3 Elsewhere on the site, work has continued widening the access track and creating laybys (Photo 4). Additional work has been carried out on the hardstanding area adjacent to the farm buildings to facilitate vehicle turning, storage and future site parking. A new access track, approximately 102 m long, has been constructed between the existing farm buildings and the hardstanding area (Photo 5), linking to the next phase of construction for the spaceport infrastructure and launch pad. Cable boxes and ducting for an Openreach data connection have been installed across the site (Photo 6). Two additional culverts have been installed to mitigate the impact of the road height increase which was trapping significant quantities of water. Work is commencing on finishing the bell mouth, with curbing anticipated to start in early March 2025. For detailed site drawings showing the location of the works, refer to Section 5 Site Plan.

Photo 4 Access road works

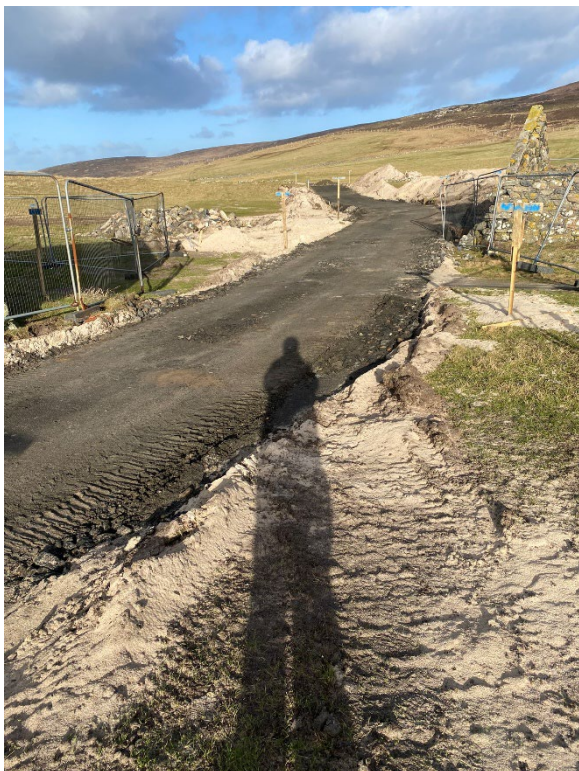
Photo 5 Access leading to future launch pad

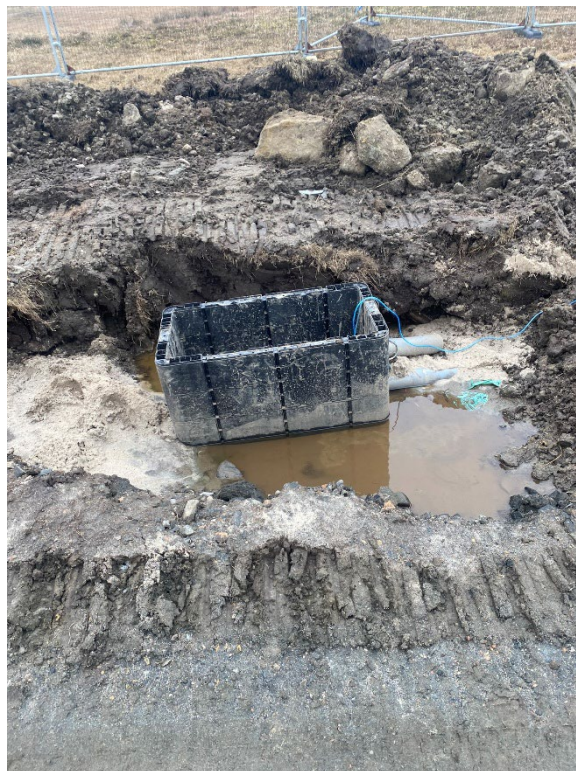
Photo 6 Installation of Openreach ducting and manholes

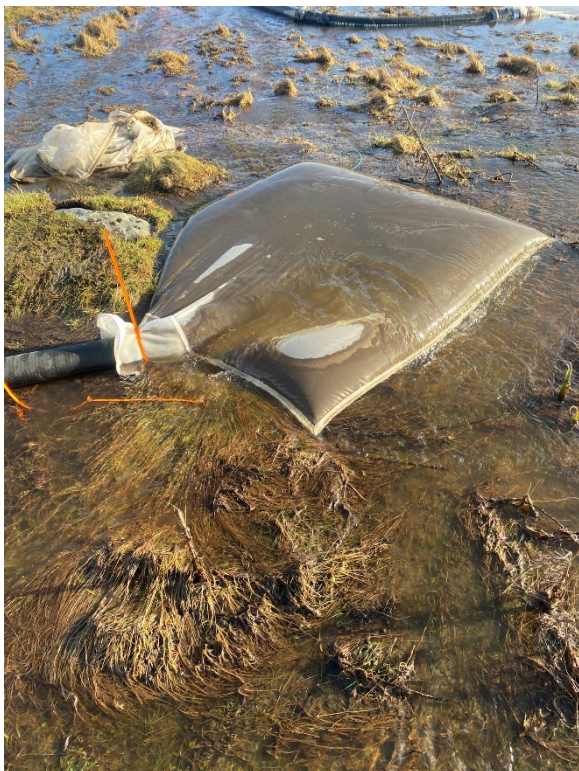
Photo 7 Silt bags to manage discharge from the desilters (removed from site within reporting period)

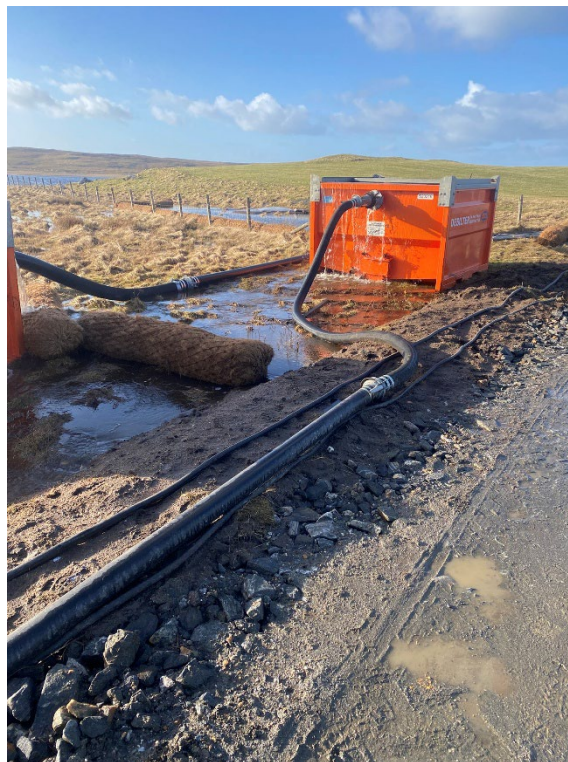
Photo 8 Desilters (removed from site within reporting period)
