SPACEPORT ONE: CONSTRUCTION ENVIRONMENTAL REPORT

Client	CnES
Project/Proposal No;	P58
Version	V1
Date	31 March 2025

Project Name:	Spaceport One: Enabling Construction Programme
Document Title:	Construction Environmental Manager Report to Planning
Client Name:	CnES
Author:	Gareth Gentles
Reviewed:	
Approved:	
Date:	31 March 2025
Version:	V1
Project / Proposal Number:	P58

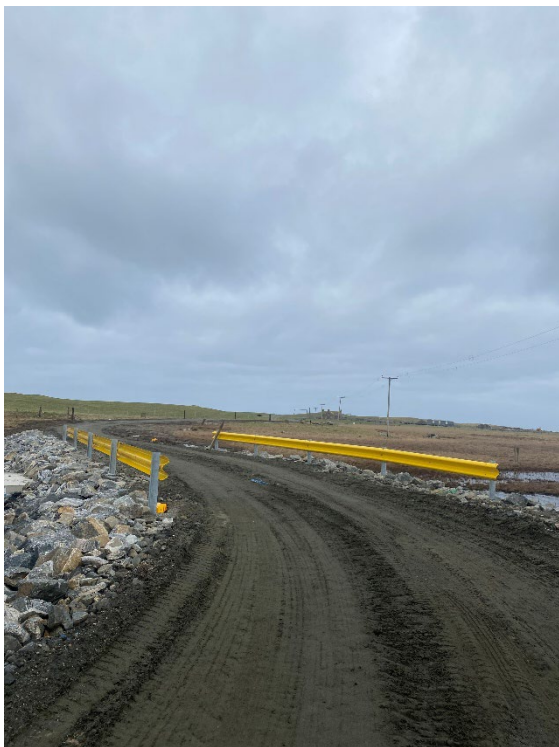
Photo 1 Crash barriers to causeway

- 2.1.1.1 The project has progressed to its final stages, encompassing the top dressing of road foundations, installation of kerbing at the bell mouth, and the creation of additional parking areas at the site entrance. The causeway work has been completed, including the installation of crash barriers (Photo 1). The fibre infrastructure for this phase has also been finalised (Photo 2). Furthermore, stock fencing has been installed around the perimeter to delineate agricultural areas from Spaceport operational zones. Additional tasks from phase two have been expedited, including foundation work for the launchpad and associated access construction. For detailed site drawings showing the location of the works, refer to Section 5 Site Plan.

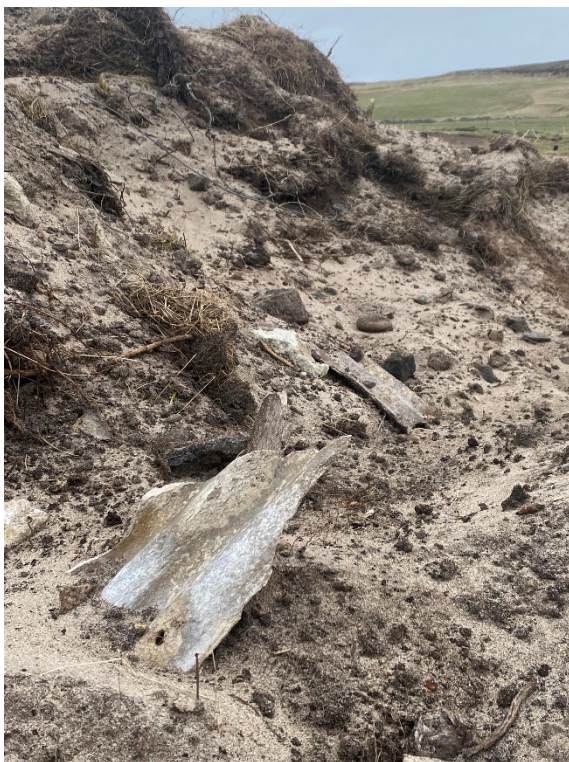
Photo 3 Asbestos debris

- 2.2.1.3 Asbestos fragments are repeatedly found in the areas around the farm buildings. Wind erosion of sand seems to be a significant contributing factor (Photo 3). All identified asbestos containing materials have been removed and disposed of as special waste.

- 2.8.1.1 MacAulay Askernish Ltd is ensuring all waste is removed from the site in accordance with their waste carrier's licence. There are no skips currently on site. Asbestos waste notes have been received for the preconstruction removal works at Byre number 3 and for areas with identified debris within the farm complex, as recorded in the Asbestos Refurbishment and Demolition report published within the CEMP.

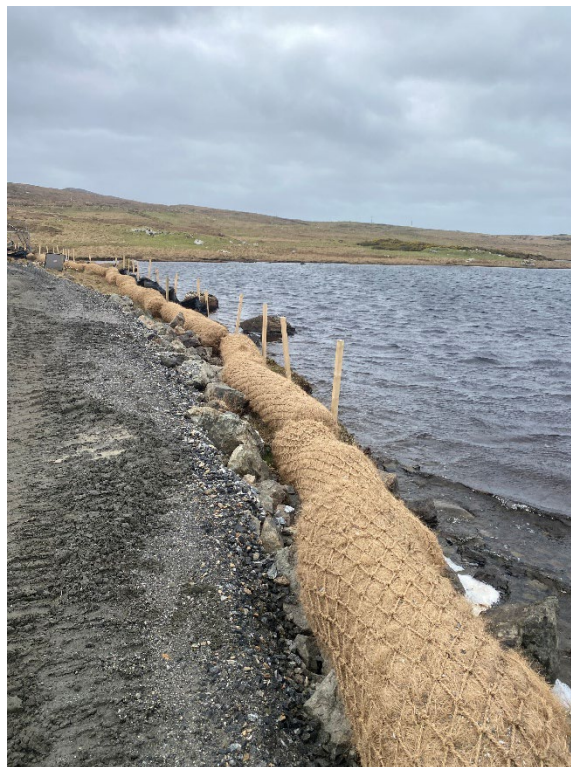
Photo 4 Silt mitigation measures

- 2.2.1.4 Regular inspections have confirmed that water runoff and silt mitigation measures are functioning effectively and settlement ponds to the front of the silt mitigation measures are starting to revegetate (Photo 4).

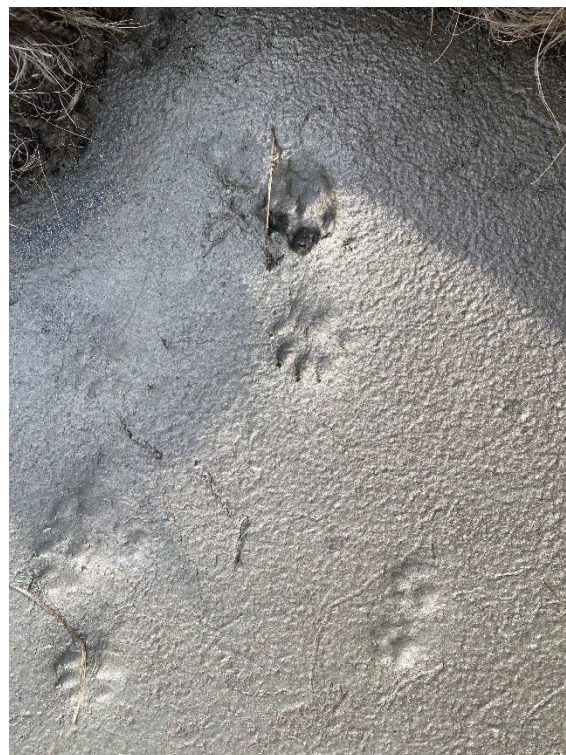
Photo 6 Otter tracks in settlement pond

- 2.6.1.1 Preconstruction otter surveys have been conducted, and mitigation measures have been incorporated into an Otter Species Protection Plan. General ecological construction mitigation measures are included in the Construction Environmental Management Plan and have been implemented on site. Speed limit signs of 10 mph have been installed on the access road for construction traffic. A site-specific ecological toolbox talk (focused on otters) was delivered to site personnel prior to construction.
- 2.6.1.2 Otter activity has been detected near the settlement pond (NF 73250 75060), with tracks leading towards upper Loch Scolpaig (Photo 6).
